HERITAGE DISTRICT AREA ASSESSMENT CITY OF MARICOPA, AZ.

SEPTEMBER 27, 2022

Authored by: CITY OF MARICOPA
Development Services Department

1. INFRASTRUCTURE CONDITION SURVEY

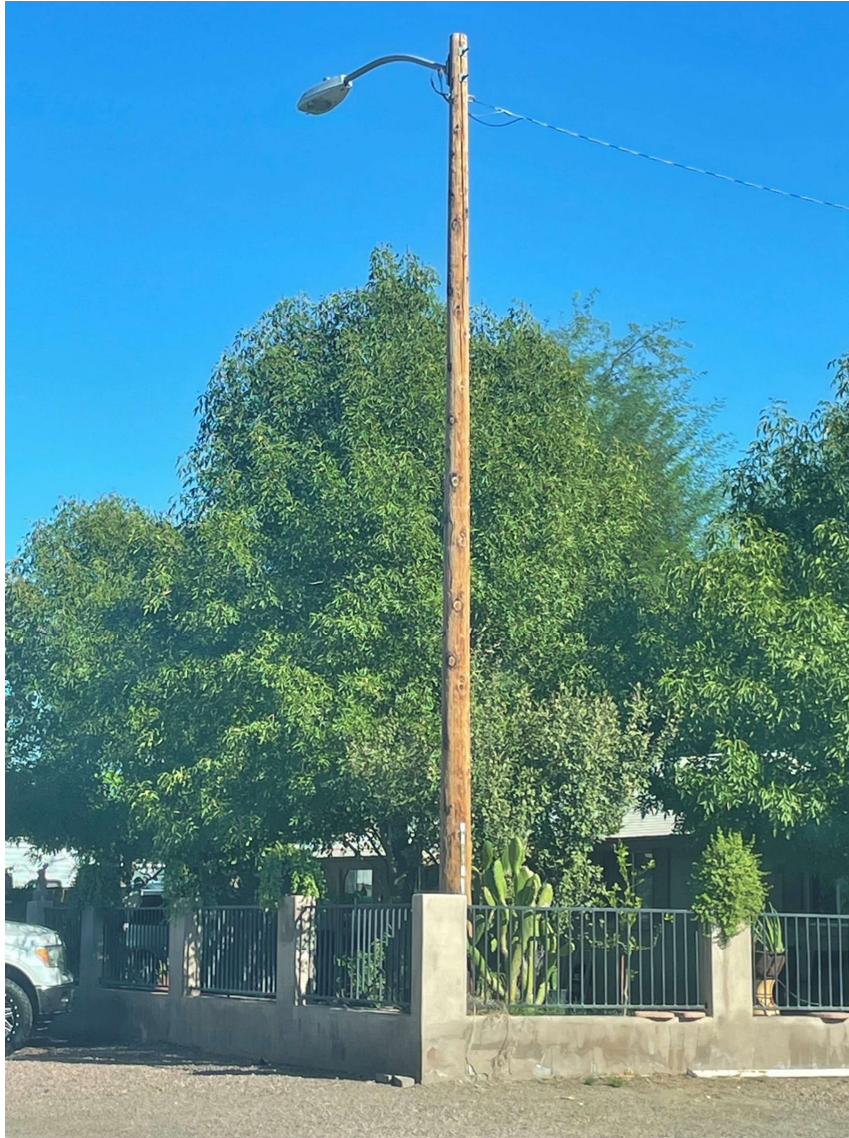
FIGURE 3.1. EXISTING LIGHT POLES

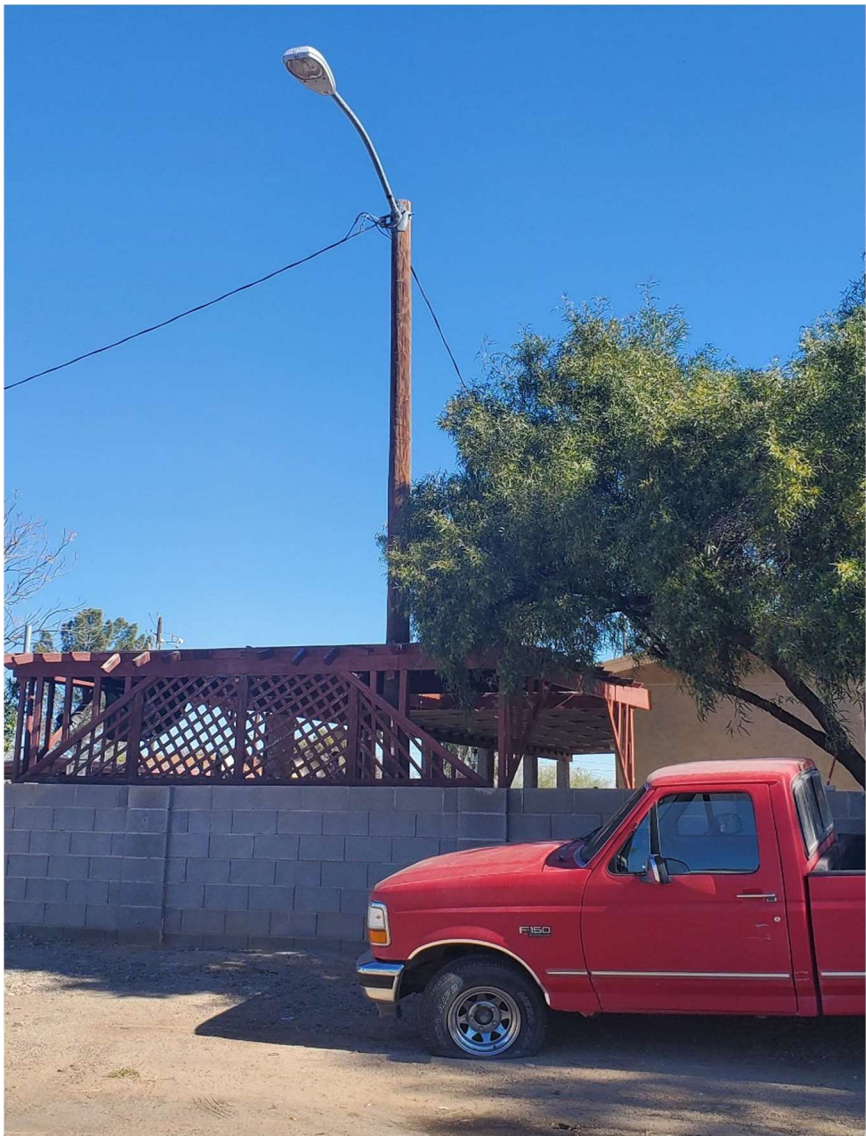
FIGURE 3.2. EXISTING LIGHT POLES
