HERITAGE DISTRICT AREA ASSESSMENT CITY OF MARICOPA, AZ.

SEPTEMBER 27, 2022

Authored by: CITY OF MARICOPA
Development Services Department

1. INFRASTRUCTURE CONDITION SURVEY

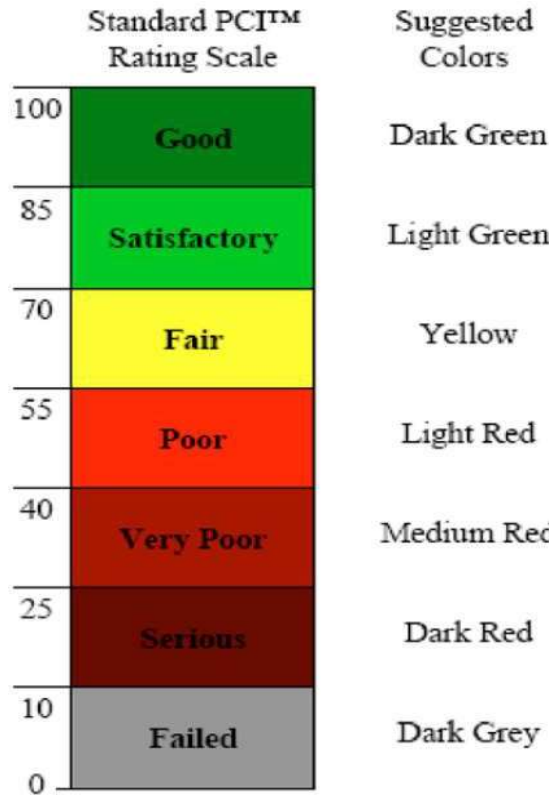
STREET	PAVEMENT CONDITION
W LEXINGTON AVE	POOR
W HATHAWAY AVE	POOR
W MADISON AVE	N/A
N ROOSEVELT AVE	FAIR
N TAFT AVE (NORTH MCDAVID RD)	POOR
N TAFT AVE (SOUTH MCDAVID RD)	VERY POOR
N WILSON AVE	POOR
W GARVEY AVE	VERY POOR
N JUSTIN DR	POOR
N CONDREY AVE	FAIR
W HONEYCUTT RD	POOR
N MARICOPA RD.	POOR
N HAMILTON AVE (NORTH HONEYCUTT AVE.)	N/A
W EDWARDS AVE	POOR
D DALLAS SMITH LN	FAIR
W ED GREEN LN	FAIR
W FRED COLE LN	FAIR
N MAIN STREET	GOOD
W STAGE COACH LN	N/A
W HERITAGE LN	N/A
W CESAR CHAVEZ LN	N/A
W BURKETT AVE	N/A

Area of roads with pavement in GOOD condition: 1,722 SY (3%)

Area of roads with pavement in FAIR condition: 10,767 SY (21%)

Area of roads with pavement in POOR condition: 28,716 SY (55%)

Area of roads with pavement in VERY POOR condition: 11,089 SY (21%)

Percentage of roads that are in poor or very poor condition: **39,805 SY (76%)**
